**GREAT PLAINS INDUSTRIAL PARK**  
LABETTE COUNTY *Kansas*

# Kansas Ordnance Plant

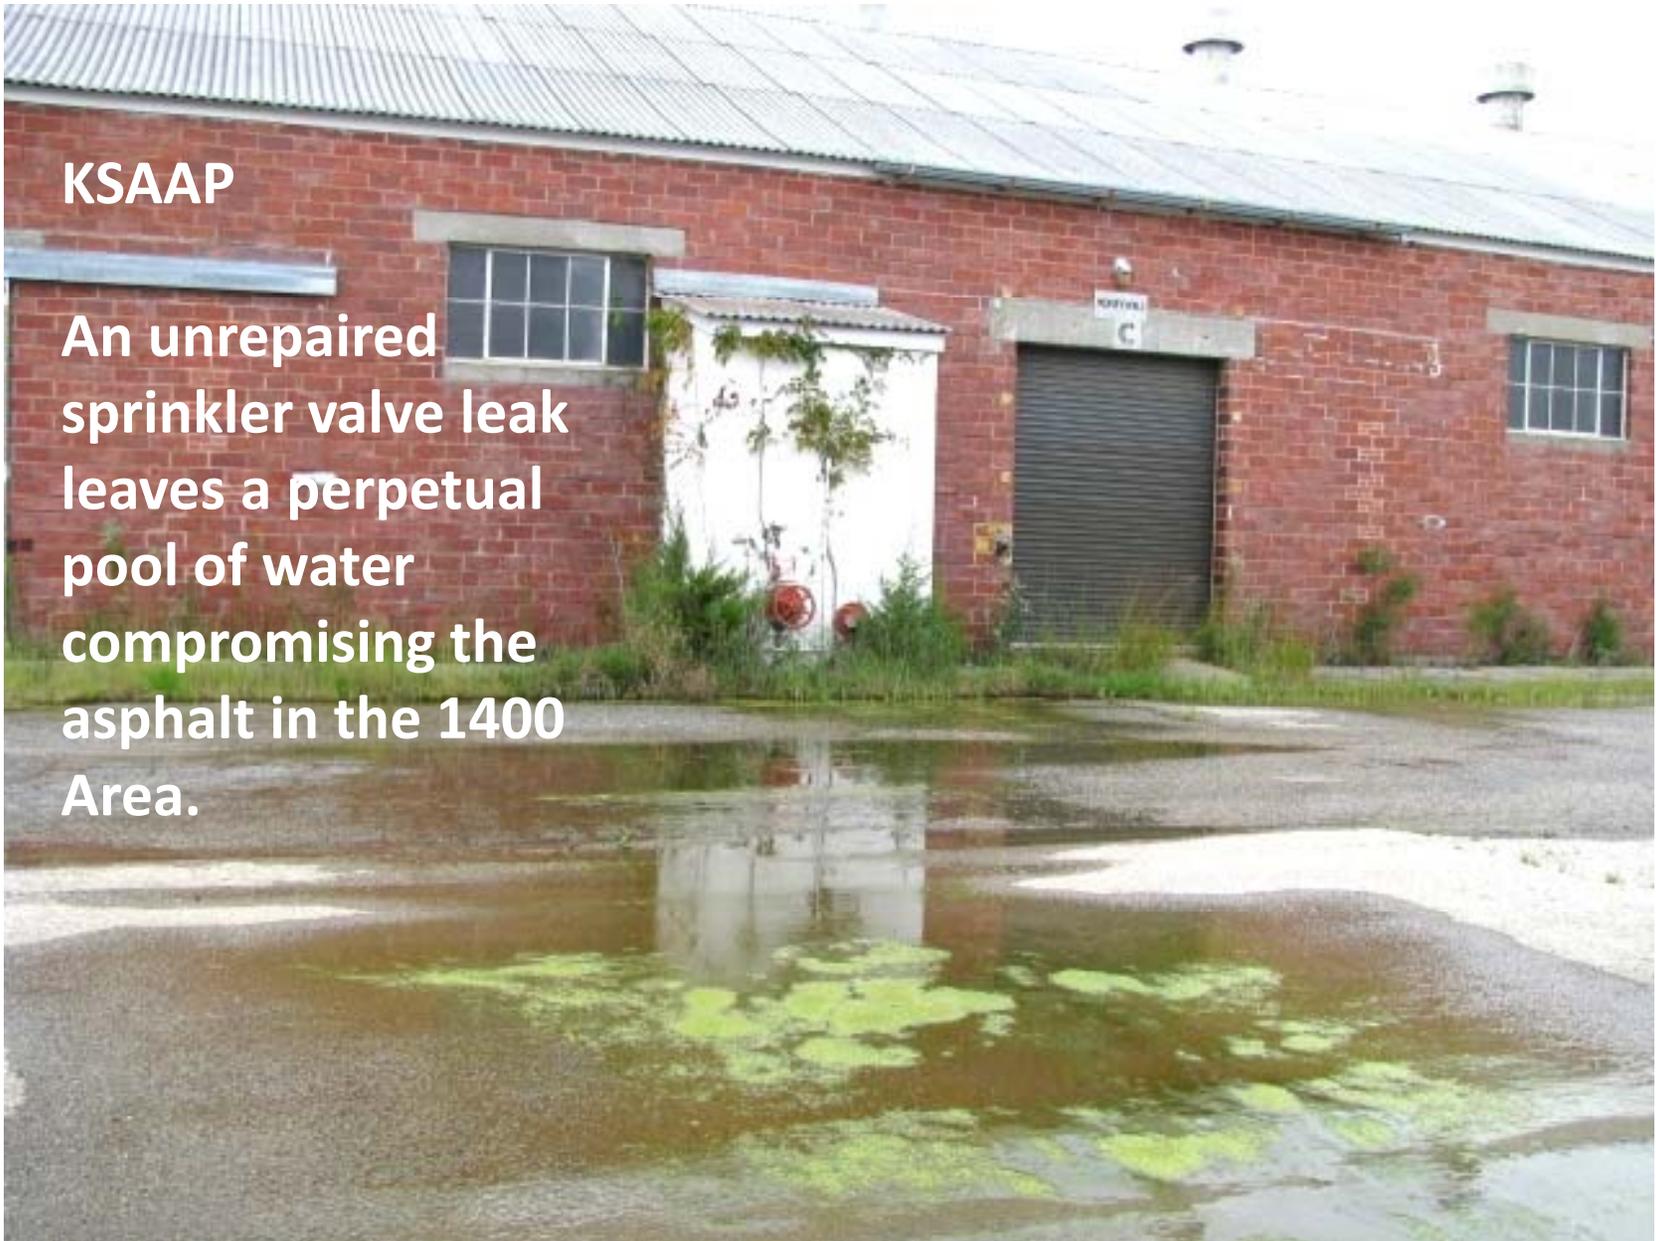
An unrepaired  
sprinkler valve leak  
leaves a perpetual  
pool of water  
compromising the  
asphalt in the 1400  
Area.

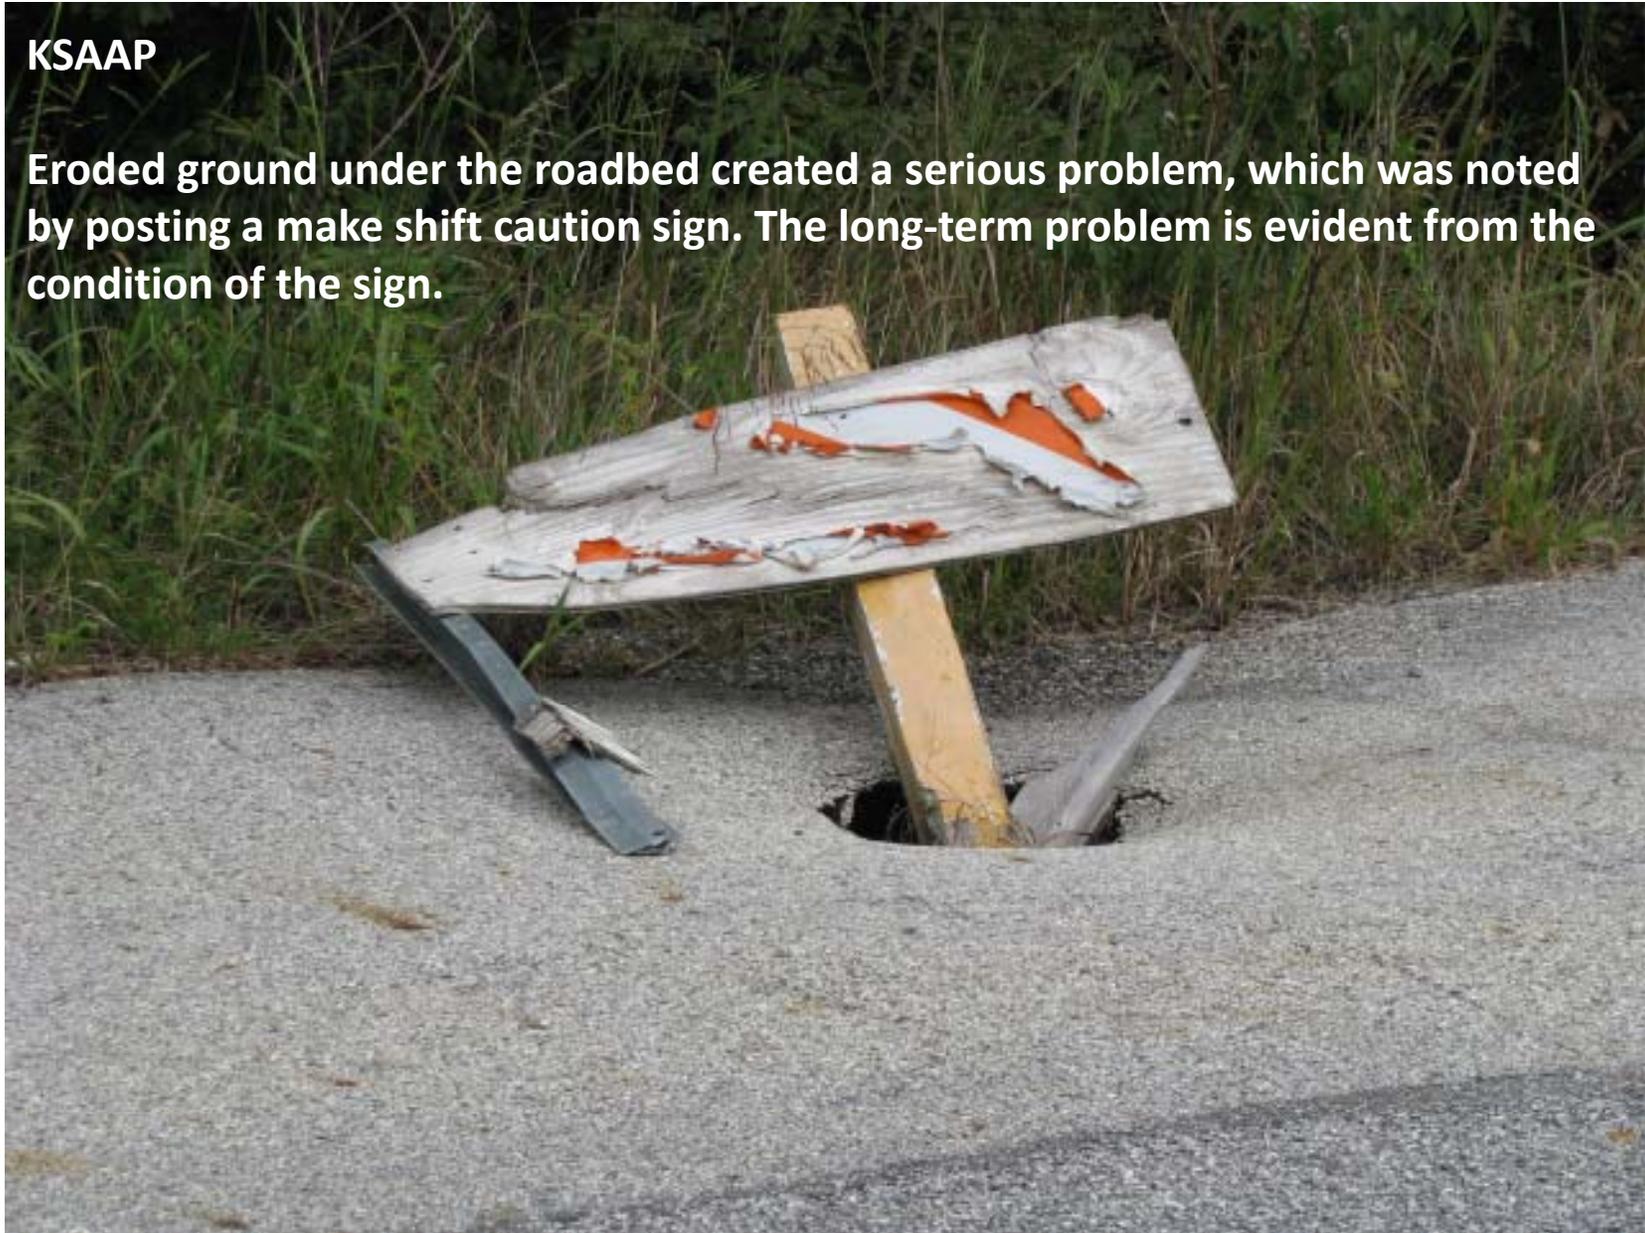
**Eroded ground under the roadbed created a serious problem, which was noted by posting a make shift caution sign. The long-term problem is evident from the condition of the sign.**

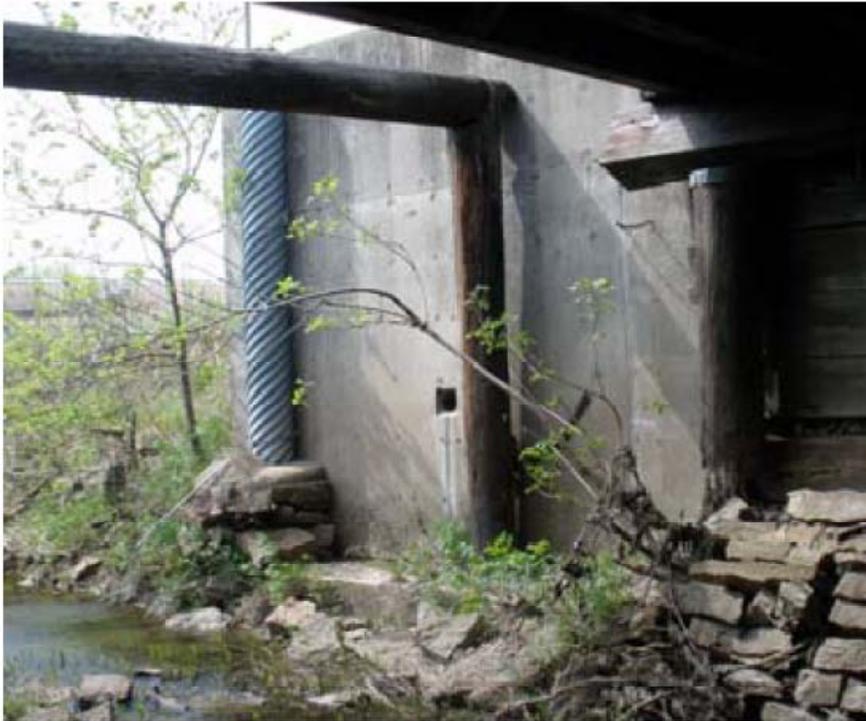
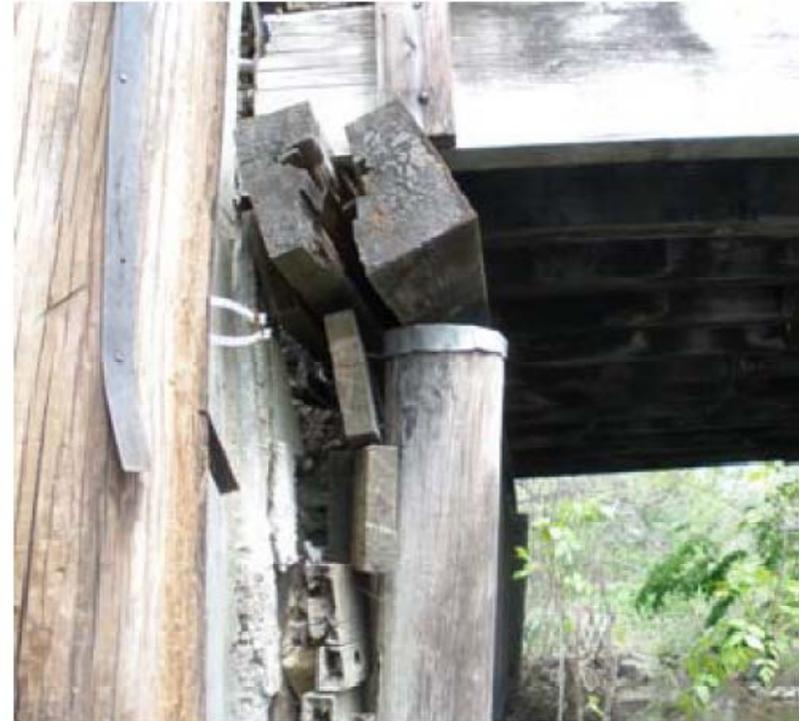
**A bridge with a rating of only 37 percent presents a significant safety hazard.**

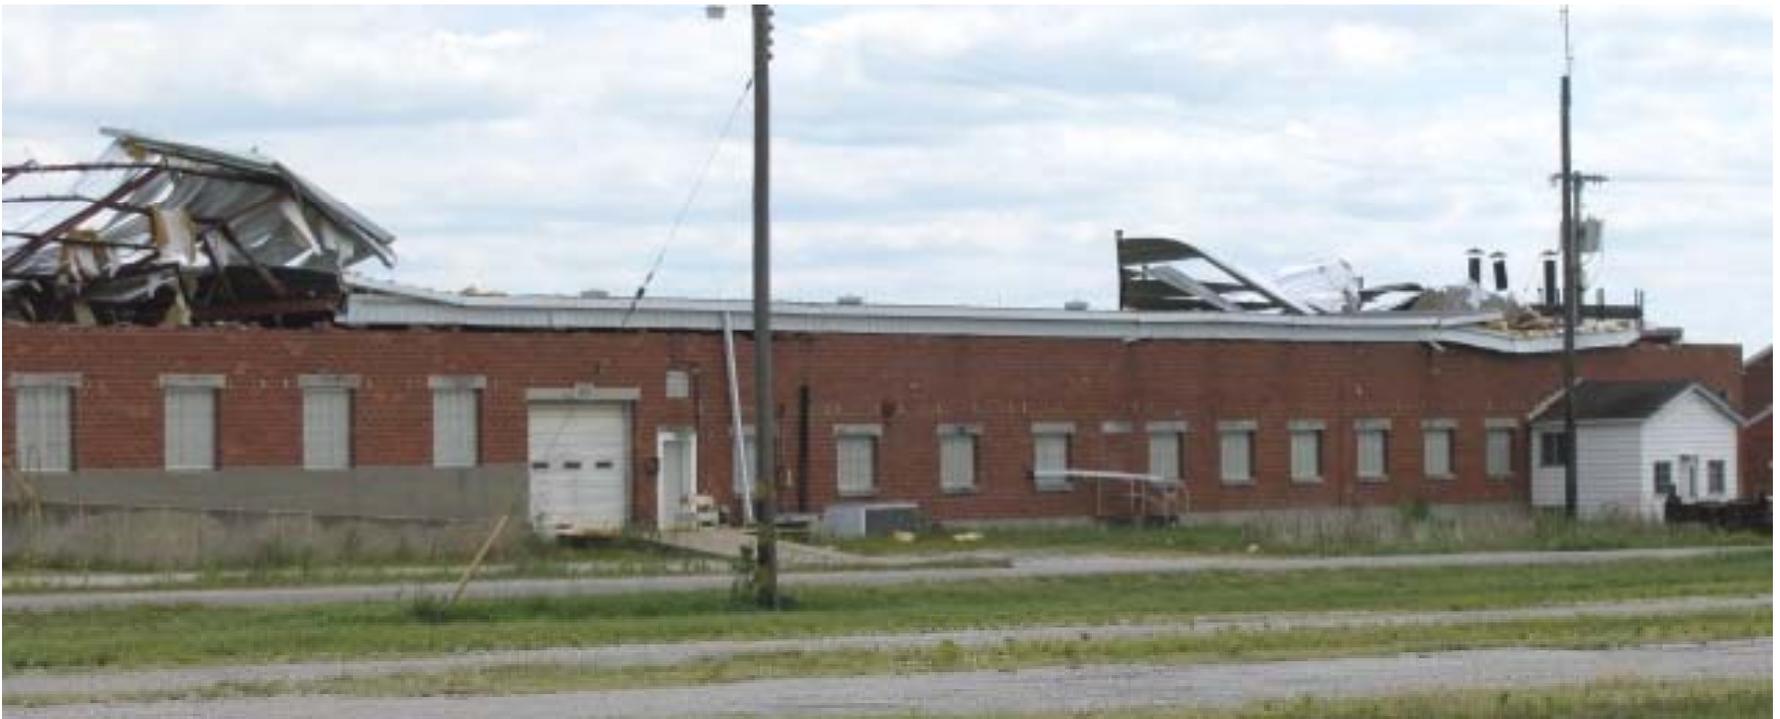
**A wind storm blew in the first couple of courses of bricks along the upper edge of this wall on a building in the 200 Area. Because repairs were not made, the next wind storm was able to enter the building with enough to lift the roof on both ends of the building, bending red iron. This building was slated for conversion to industrial use.**

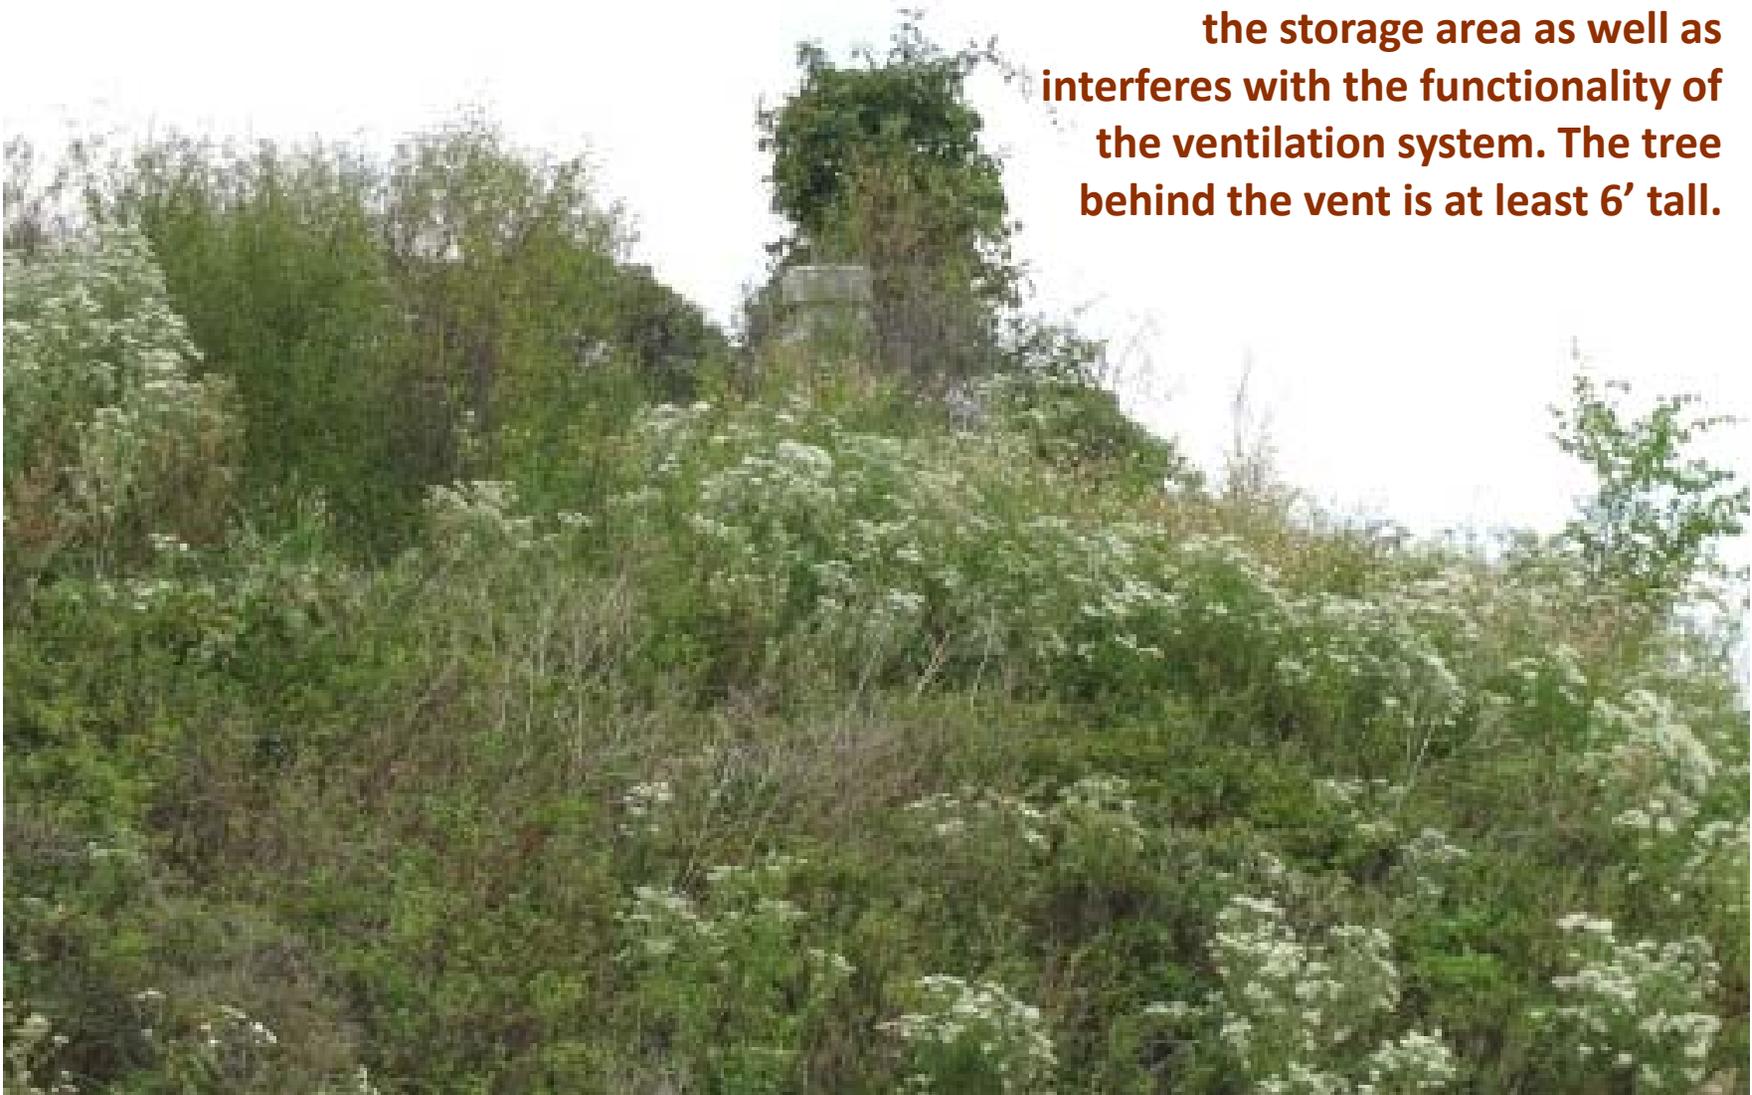
**Long-ignored overgrowth on igloos compromises the value of the storage area as well as interferes with the functionality of the ventilation system. The tree behind the vent is at least 6' tall.**

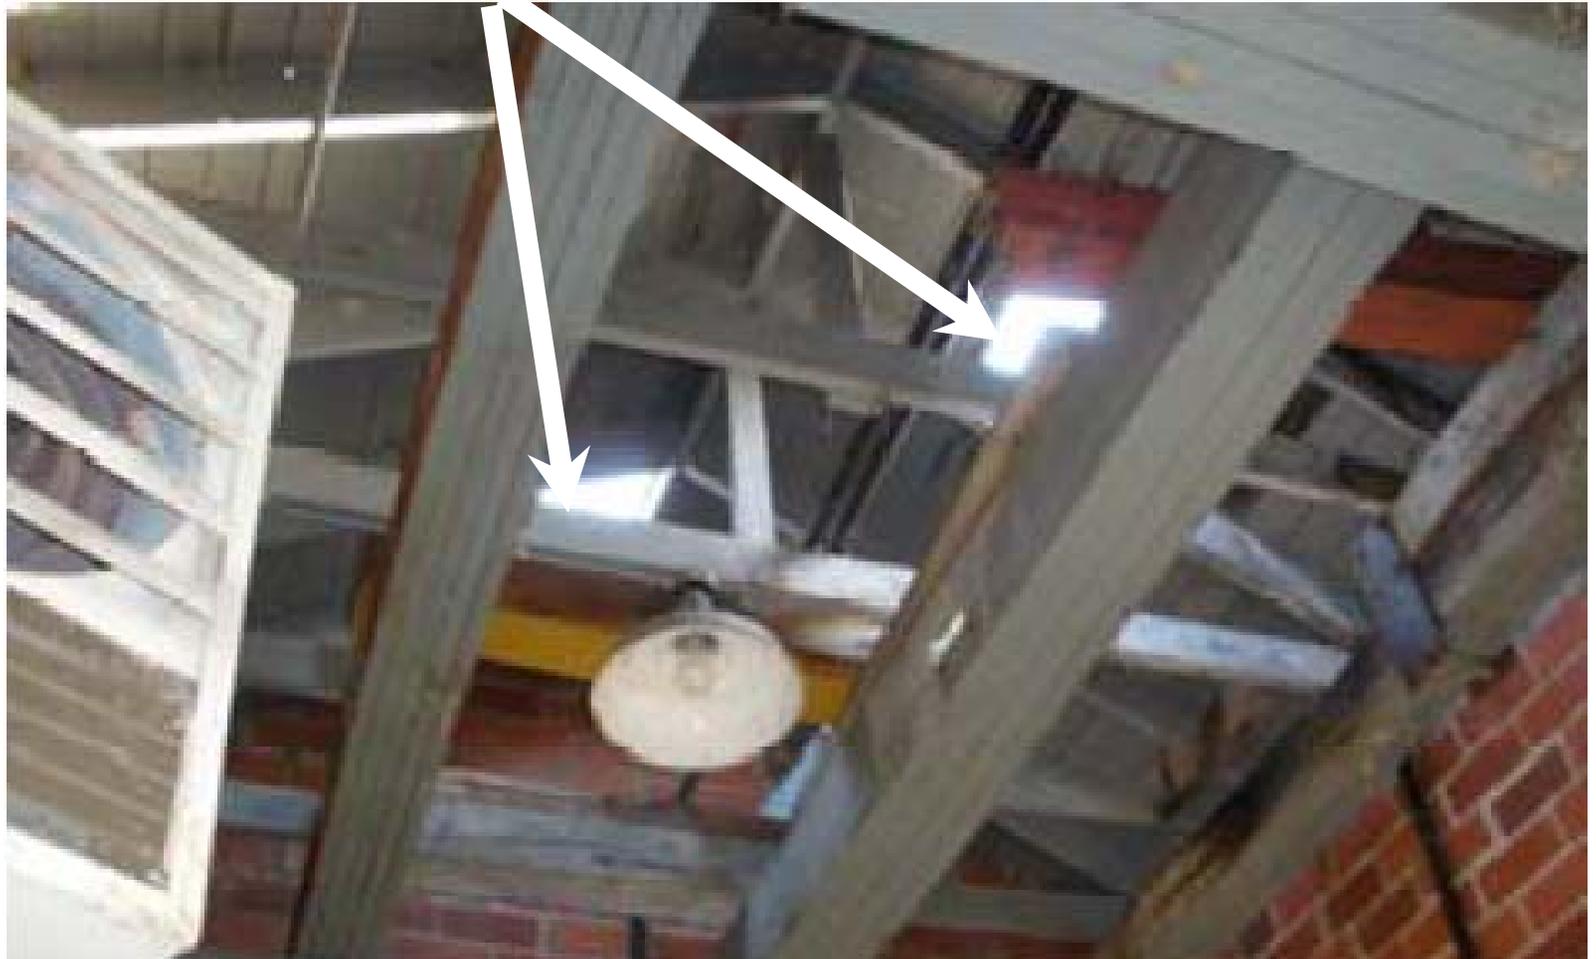
**Two holes in the roof ,each measuring 2' x 2', created to accommodate a piece of equipment that was poorly selected and had to be removed. The holes were never repaired and allow rain, snow, birds, etc. inside the building, as well as allow massive heat loss during the winter.**
